Operator Error Strands Vestas Wind

Charts and electronics played small role in Volvo race mishap.

By Technical Editor Ralph Naranjo

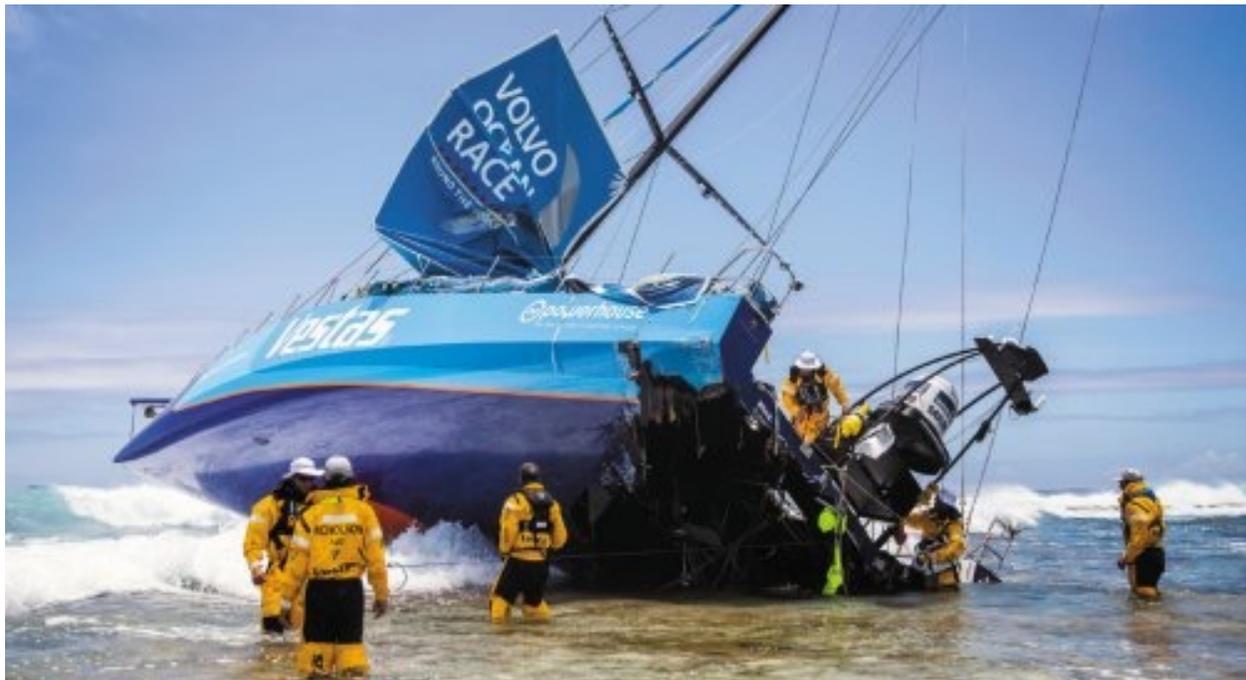
Neglect of basic navigational procedures resulted in Vestas Wind being driven onto a charted reef in the Indian Ocean.

It is clear by watching the moment of impact that no one aboard had any idea the boat was approaching a surf-swept fringing reef. The Bruce Farr-designed VO65, charged into the surf zone at 19 knots, snapping off the leeward dagger board as if it were a toothpick. Pounded by waves, the rudders were ripped from the hull, and the stern quarter was pulverized.
